*NIST Special Publication 862*

# 1994 Northridge Earthquake

## Performance of Structures, Lifelines, and Fire Protection Systems

*Diana Todd, Nicholas Carino, Riley M. Chung, H. S. Lew, Andrew W. Taylor,  
William D. Walton, James D. Cooper, and Roland Nimis*

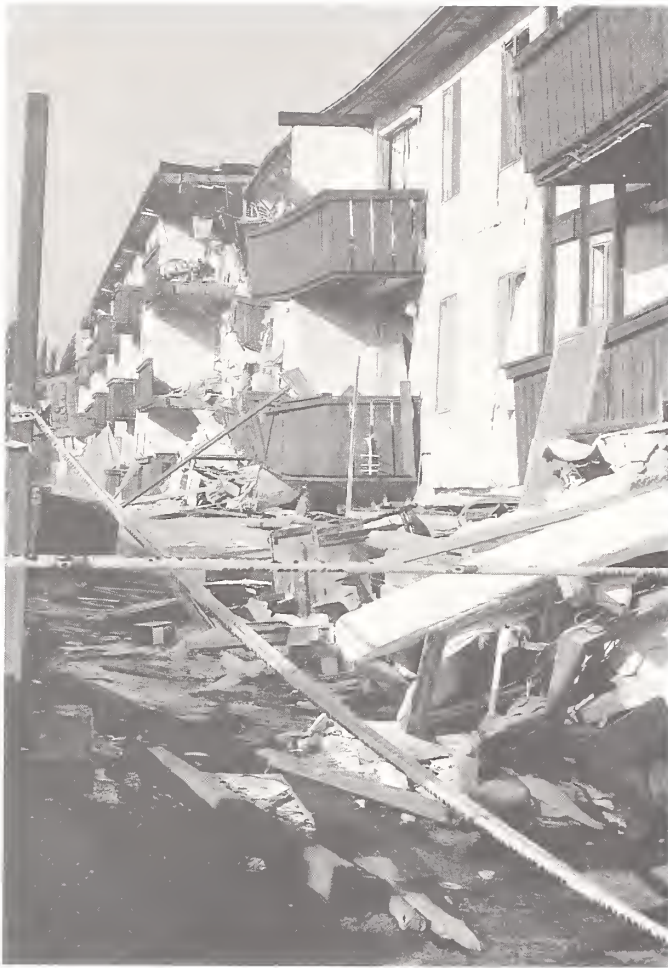
Figure 3.4. At the Northridge Meadows apartment complex near the epicenter the first story in several of the buildings collapsed, killing sixteen people. The second and third stories remained essentially intact. Large portions of the first story in these buildings were open space for parking. This type of collapse occurred in a significant number of similar apartment buildings throughout the affected area.

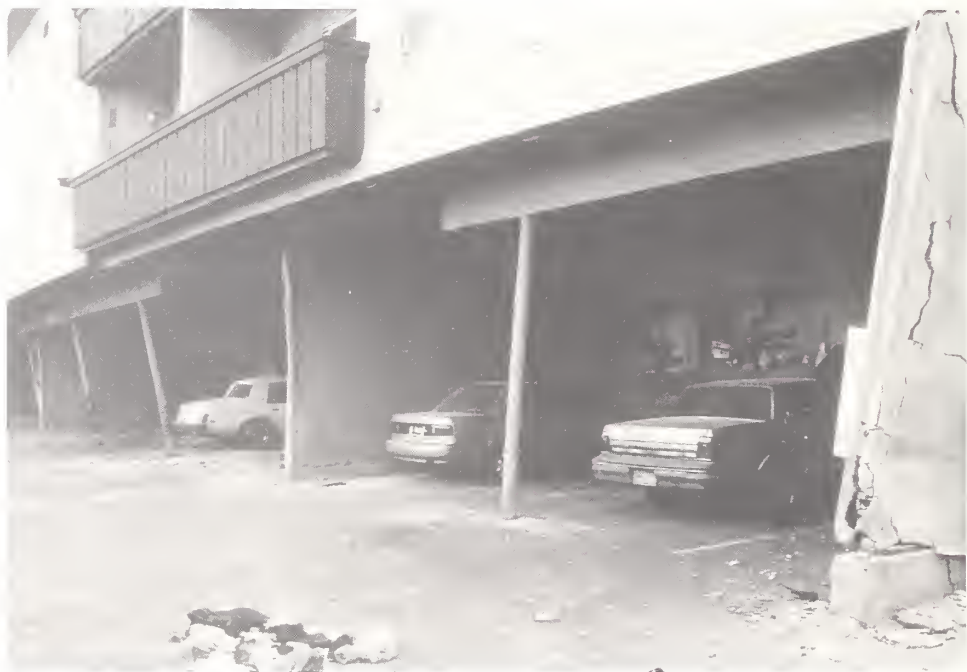
Figure 3.5. Steel pipe columns between parking bays supported the upper stories of the Northridge Meadows apartment buildings. Few of the buildings in the north half of the complex collapsed, but all were damaged.

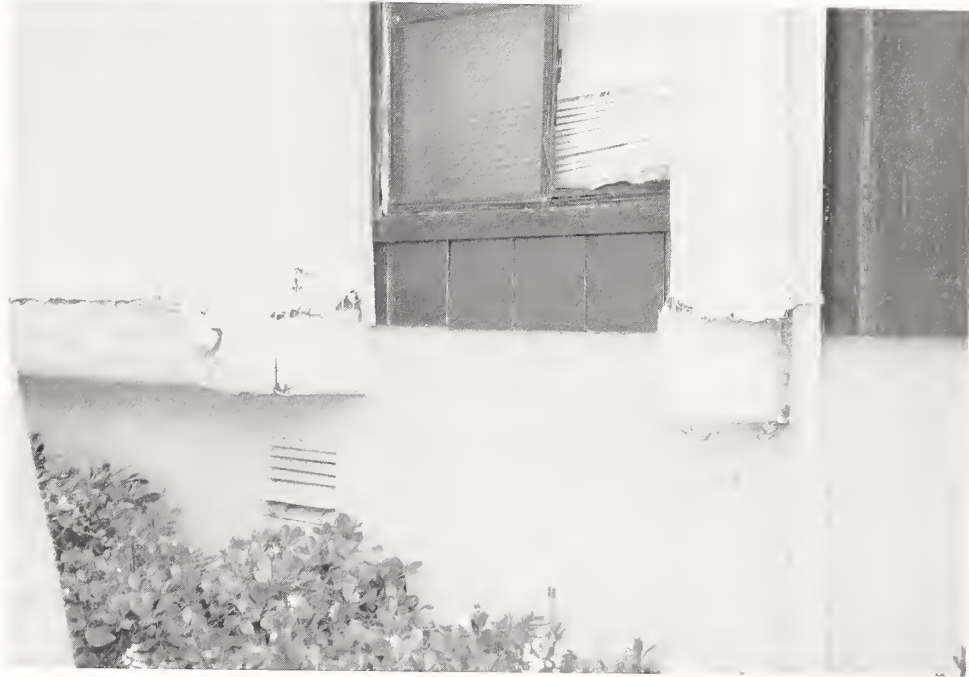
Figure 3.8. Horizontal cracks at the interface of the foundation wall (usually concrete) and the first story (typically wood-framed with stucco facade) were often seen in damaged low-rise apartment buildings.

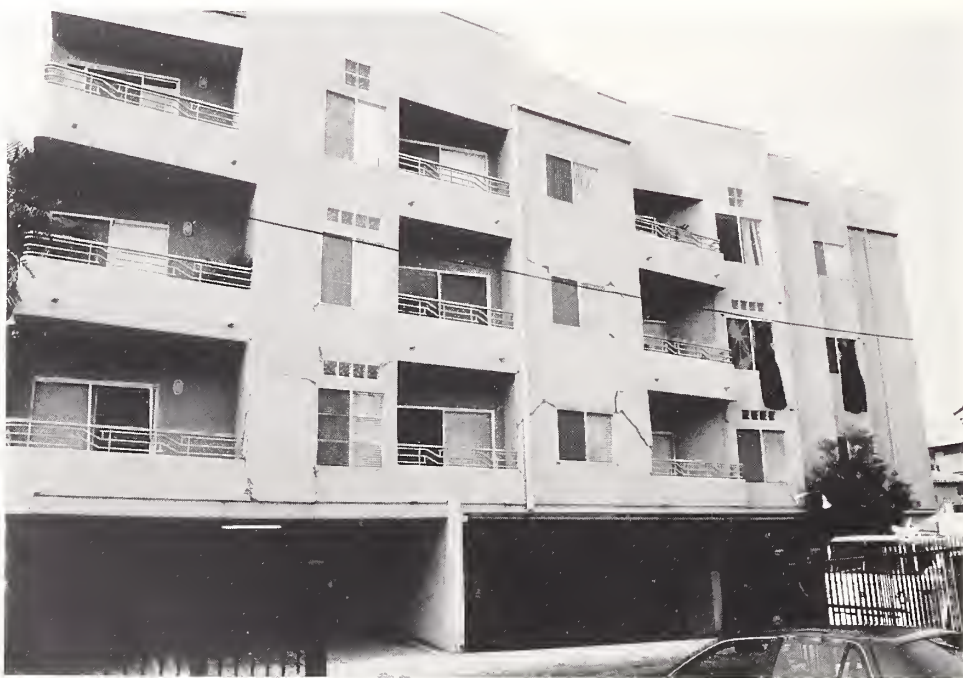
Figure 3.9. Typical damage in to low-rise apartment buildings included diagonal cracks in the stucco facade at the corners of windows and other openings.

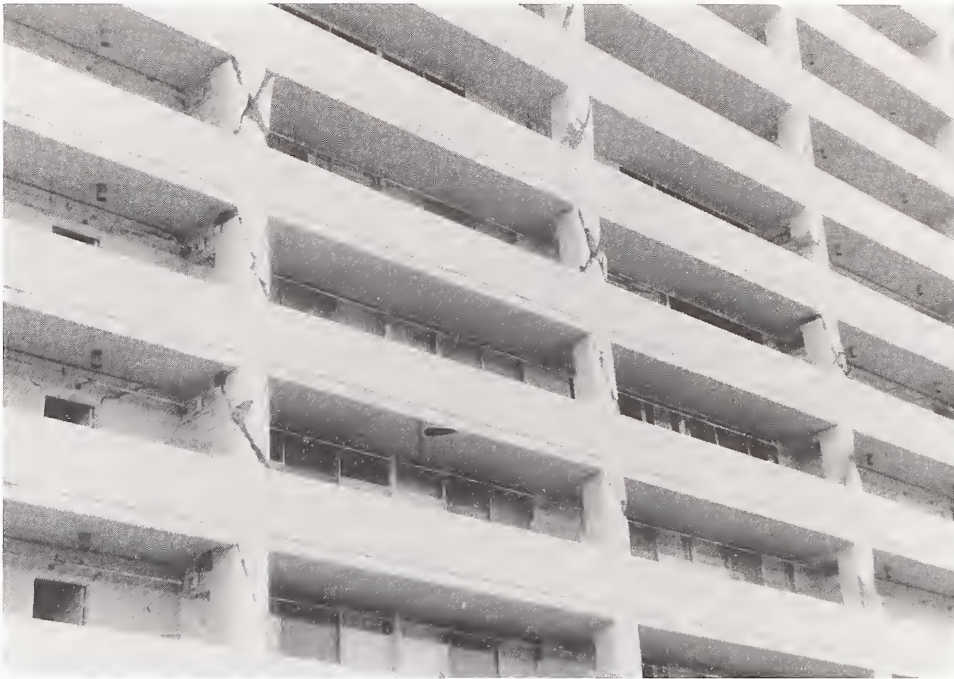
Figure 3.14. The back of the Champagne Towers building was badly damaged. The railings here are solid infill, which effectively stiffen the lower half of the columns. The shortened upper half of the columns were forced to accommodate all the displacement, and they failed in shear.

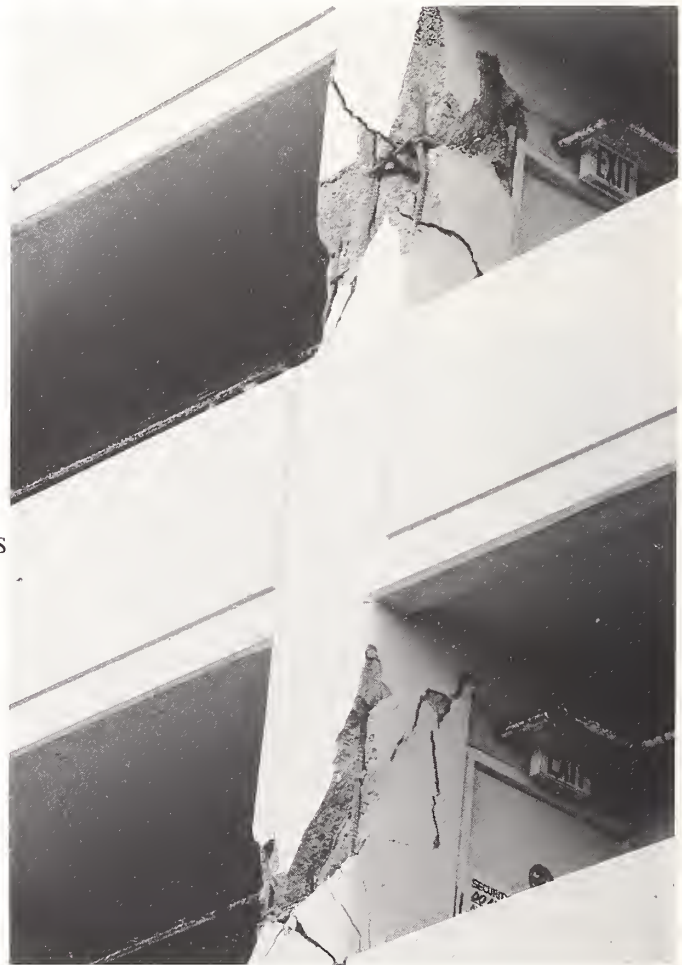
Figure 3.15. A closer view of the failed columns at the back of Champagne Towers shows minimal transverse reinforcement.

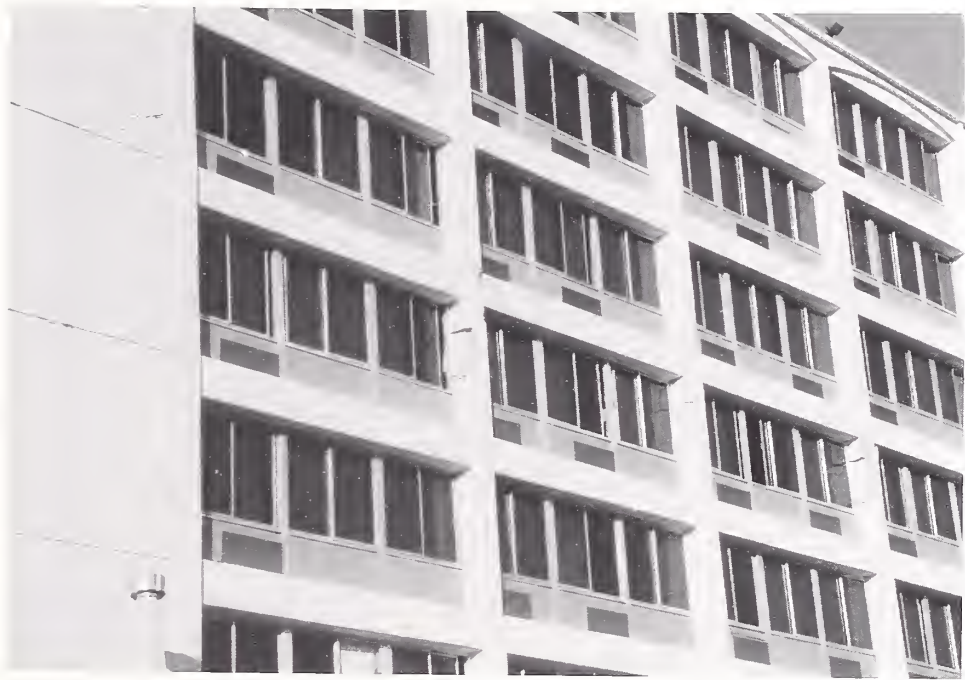
Figure 3.16. The bottom two stories of the concrete frame Holiday Inn in Van Nuys were damaged in the 1971 San Fernando quake and subsequently repaired. In the 1994 Northridge quake, damage was concentrated at the top of the fourth floor columns.

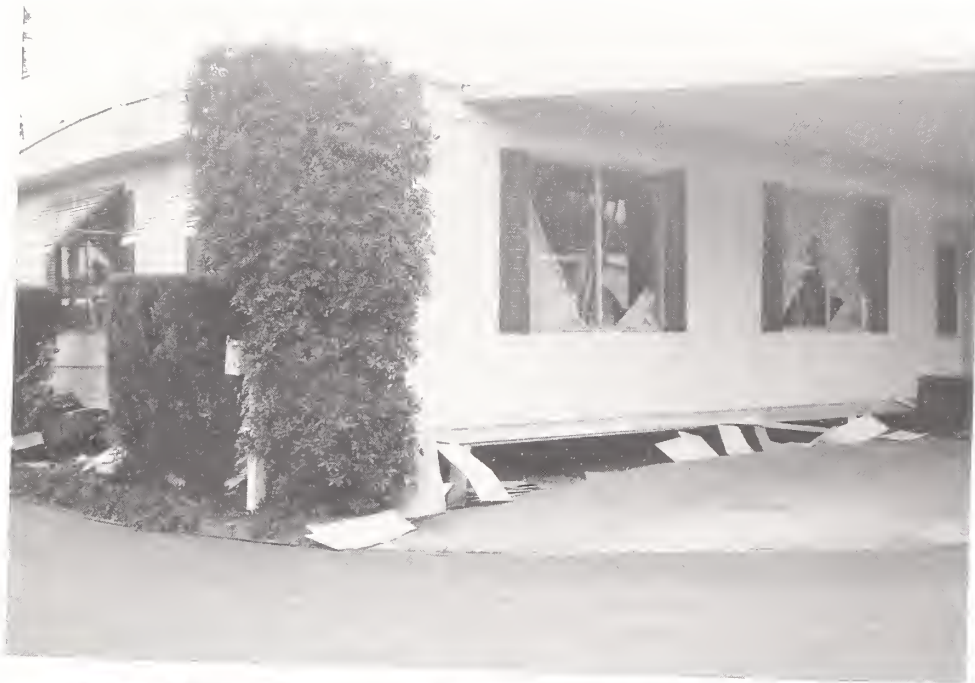
Figure 3.19. Damage to manufactured homes caused by collapsed supports was common.

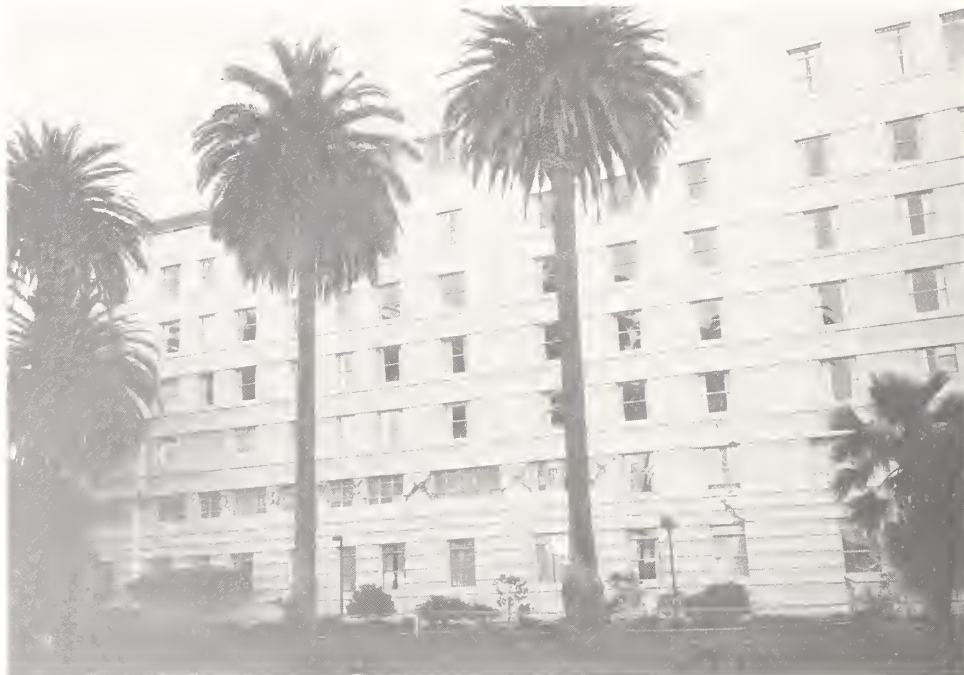
Figure 3.23. The seven-story northwest wing of St. John's hospital in Santa Monica experienced severe X-cracking in the piers between the second story windows.

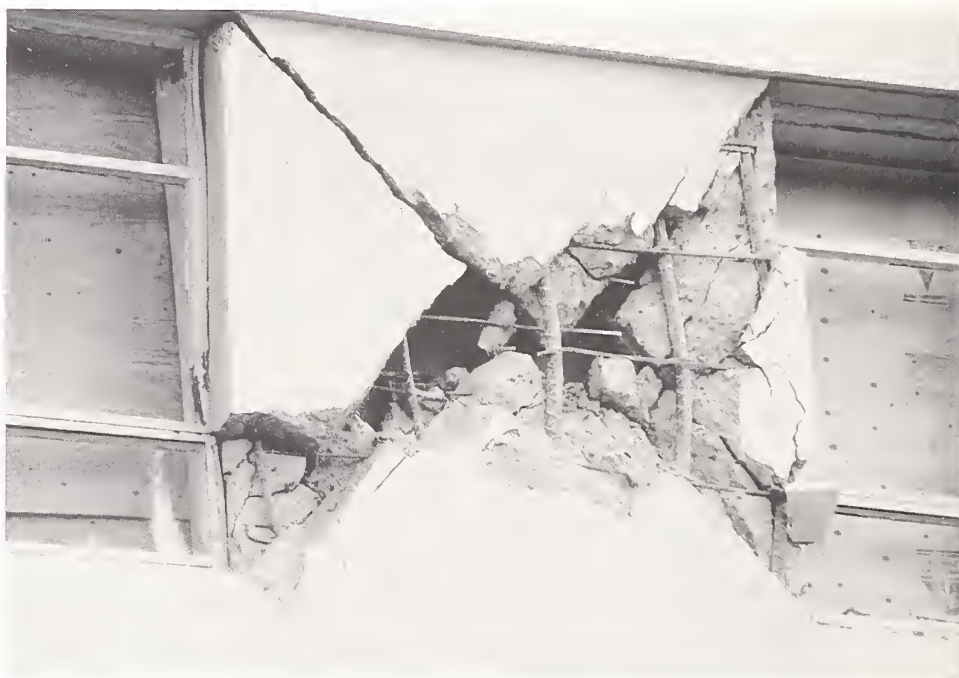
Figure 3.24. The transverse reinforcement in the St. John's hospital window piers was spaced at about 150-200 mm on center with 90° hooks at the ends, typical for construction of its age (about 50 years old).

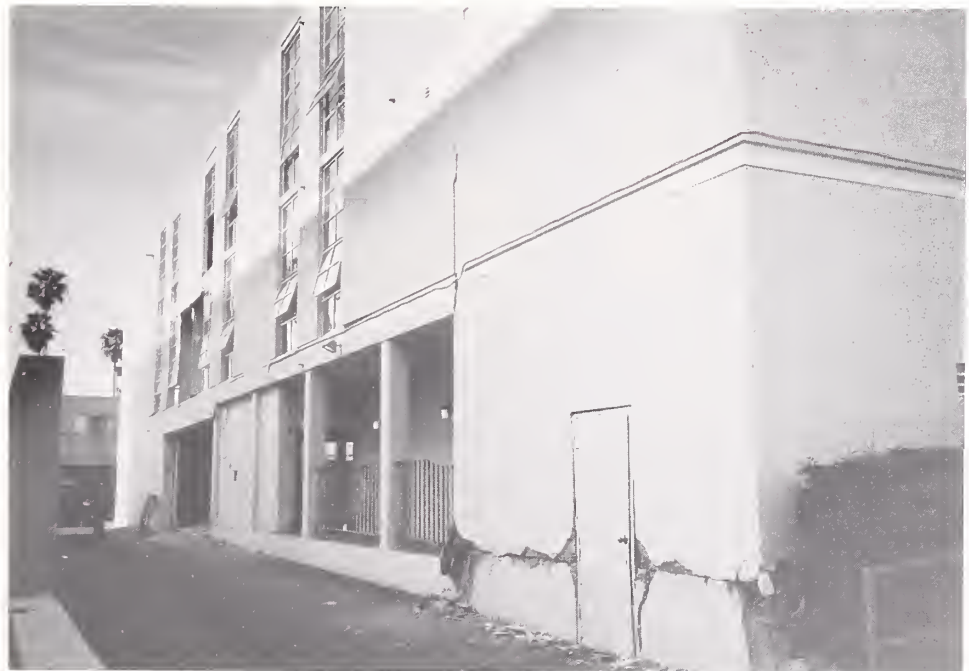
Figure 3.27. The facade of the five-story Berkley Convalescent Hospital directly adjacent to the St. John's Hospital complex consisted of two wythes of brick masonry with a reinforced and grouted space between. In some places, all three layers of this facade were destroyed along lines of diagonal cracking. The facility was evacuated.

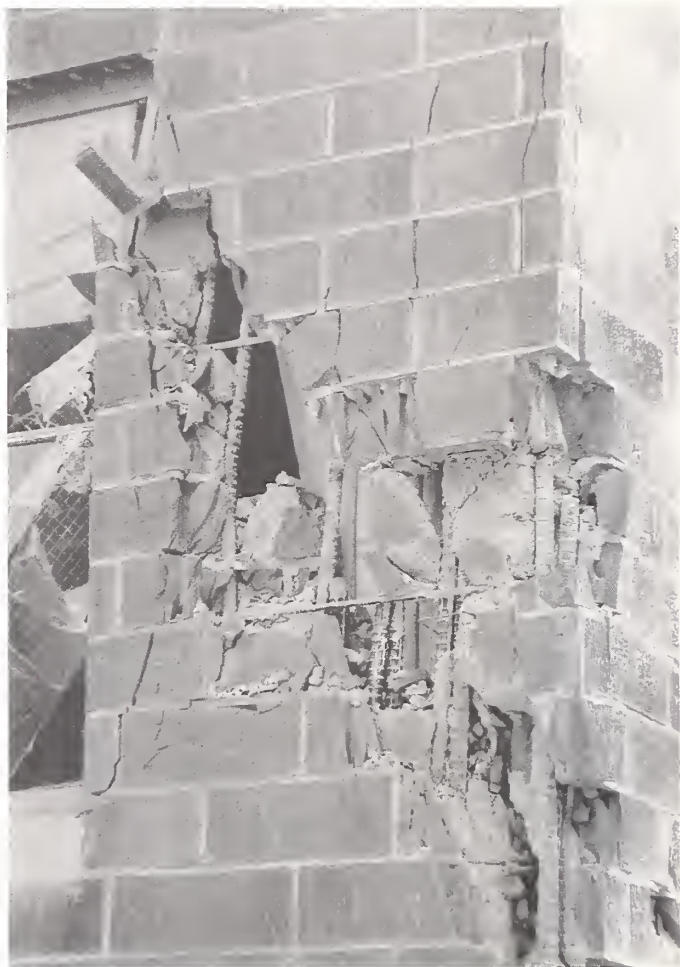
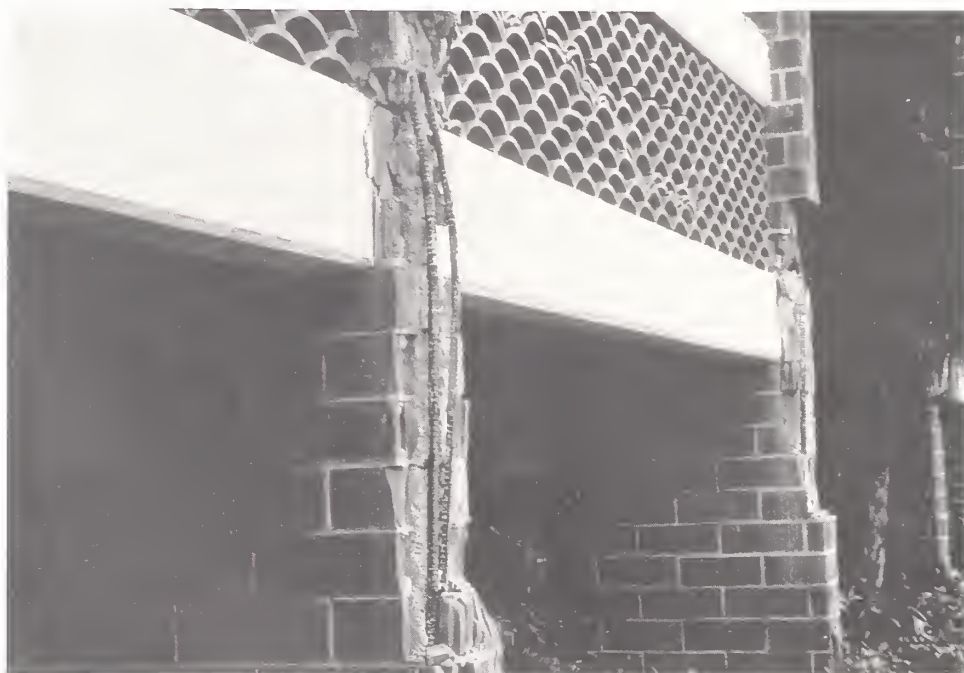
Figure 3.28. Two faces of the Berkley Convalescent Hospital had wing walls separating balconies. The ends of these wing walls spalled at the lower stories.

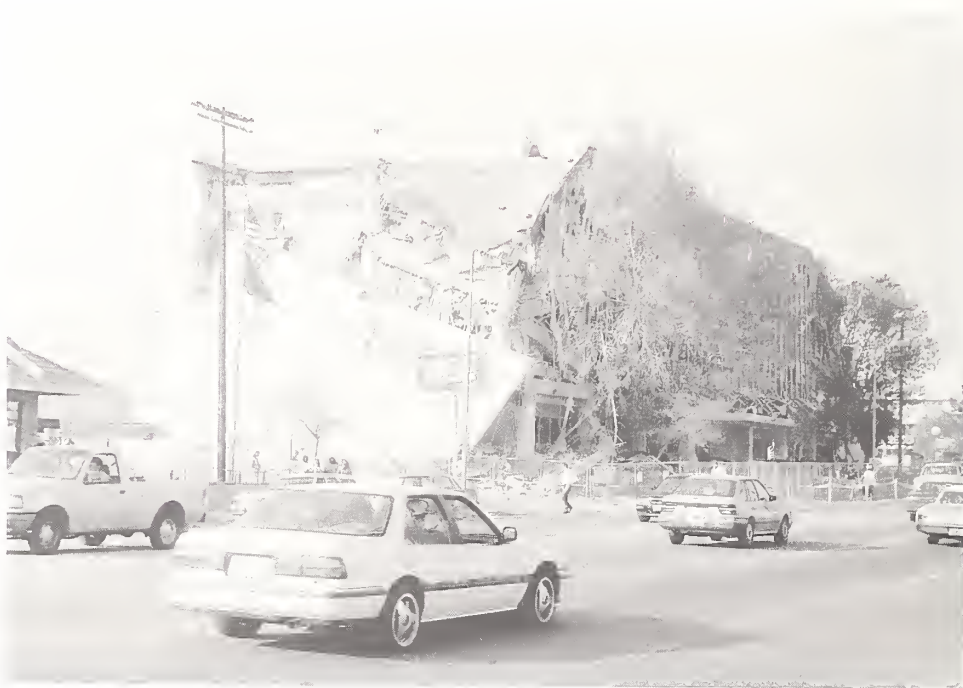
Figure 3.42. Both end walls of the Kaiser Permanente building slid, partially intact, to the ground. The south wall is pictured here. Both ends of the building suffered damage to the concrete frame at all story levels, while the middle half of the building, except for the second story, remained intact.

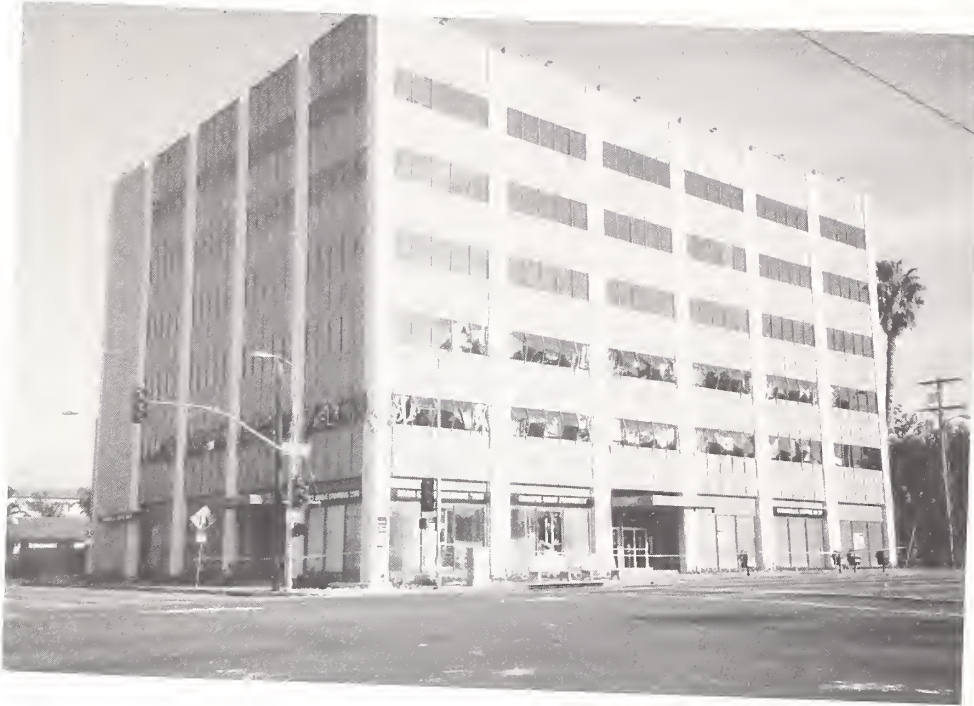
Figure 3.45. The six-story L-shaped concrete-frame Barrington Building on Olympic Boulevard in West Los Angeles lost its vertical-load carrying capacity at the second story.

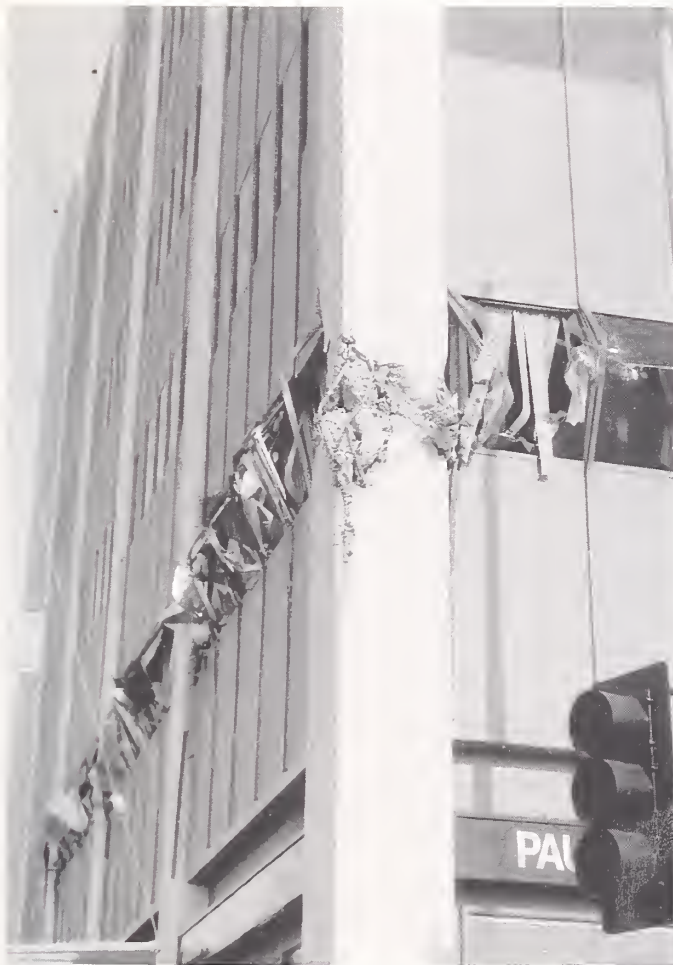
Figure 3.47. The cracking in the concrete columns at the second story was so extensive that the vertical-load carrying capacity of the building was affected. The building settled 50-100 mm at the second story, as these bulging window frames attest. The worst damage was at the southeast corner, the outside corner of the L-shape, pictured here. The building, which developed a slight list, was demolished within days of the quake.

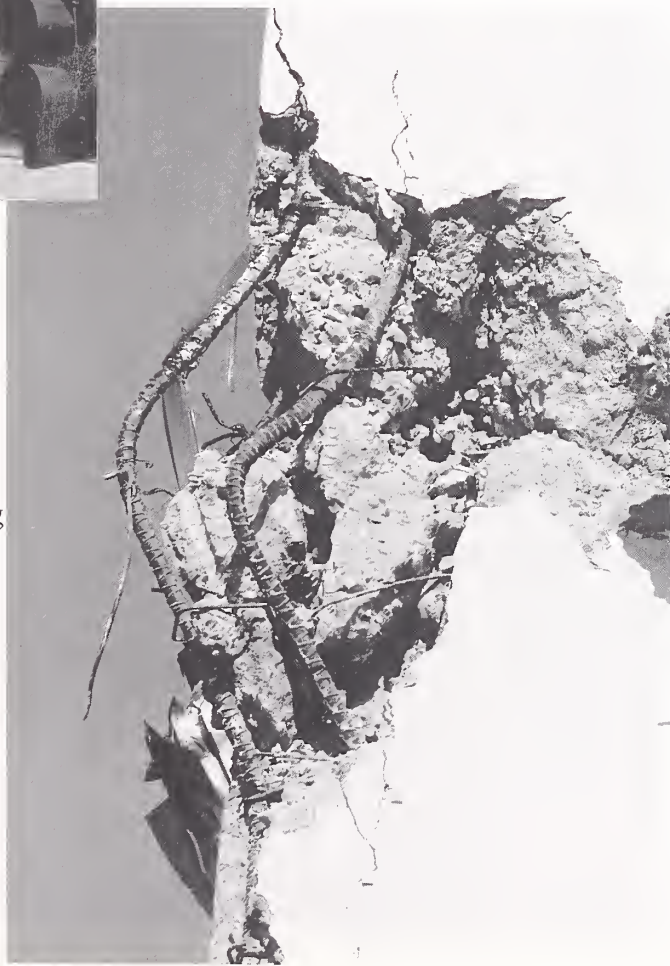
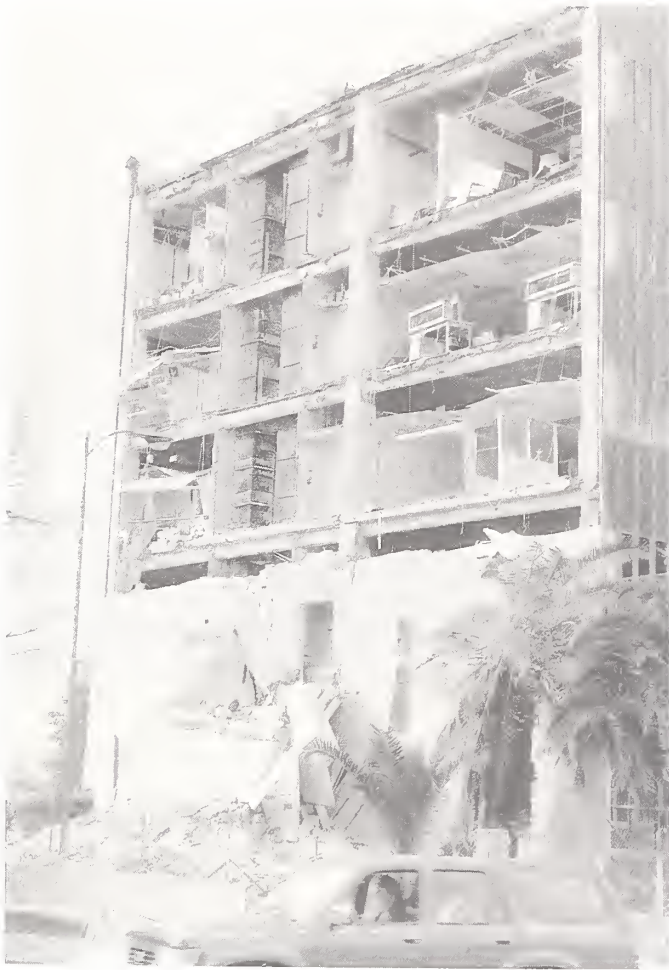
Figure 3.49. The east end wall and stair tower of a five-story apparently steel-framed office building on Sherman Way in Reseda collapsed. The enclosing masonry wall became detached from the structure and slid to the ground, with the upper stories remaining intact. The doorway opening in the wall, shown here resting at about the second story level, originally provided access from the top story to the stair tower.

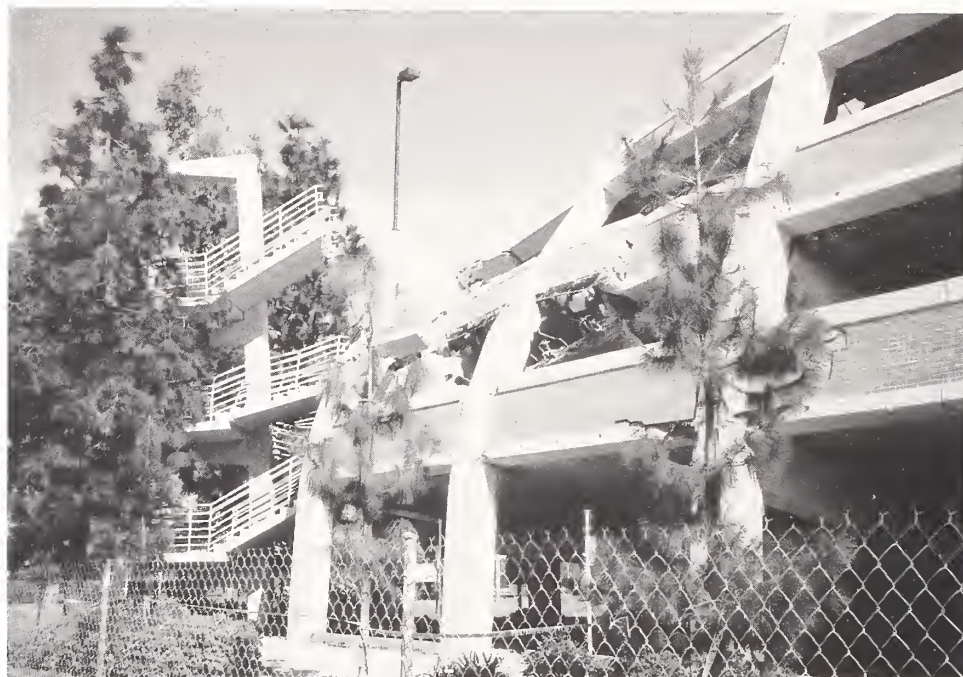
Figure 3.60. The three-year old four-level parking garage at the Northridge campus of California State University partially collapsed in the earthquake. The collapse apparently started at the interior, causing the exterior frame to be pulled in to the middle of the structure. Precast concrete "trees" were connected to form a moment-resisting frame at the exterior of the structure.

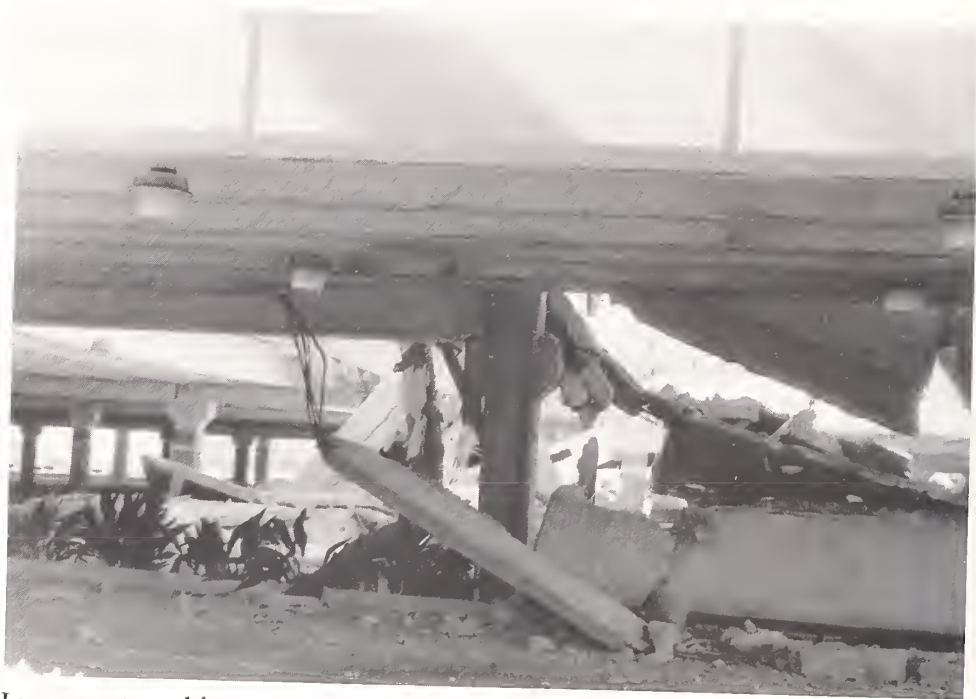
Figure 3.68. In precast parking garages, the support of the double-tees that comprise the floors is a vulnerable link in the system. This garage, at the north end of the Northridge Fashion Center, illustrates a common failure: the double-tees pulled off their supports, leaving the supporting elements essentially intact.

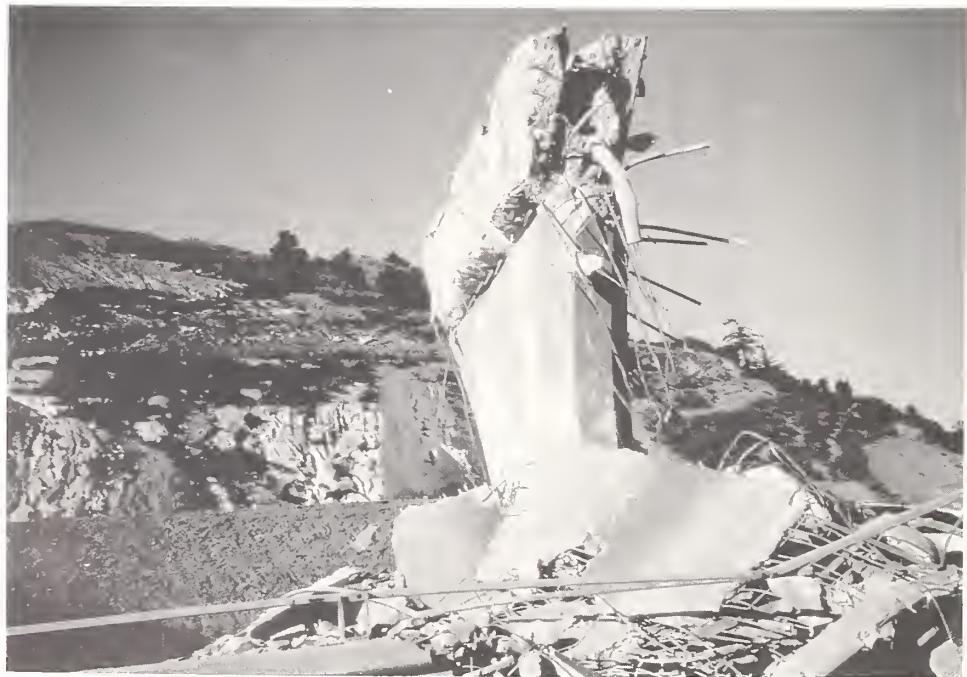
Figure 4.12. Damage at Pier 3 of the SR14/I5 Separation and Overhead, Ramp C, looking to the west (Photo courtesy of EERC).

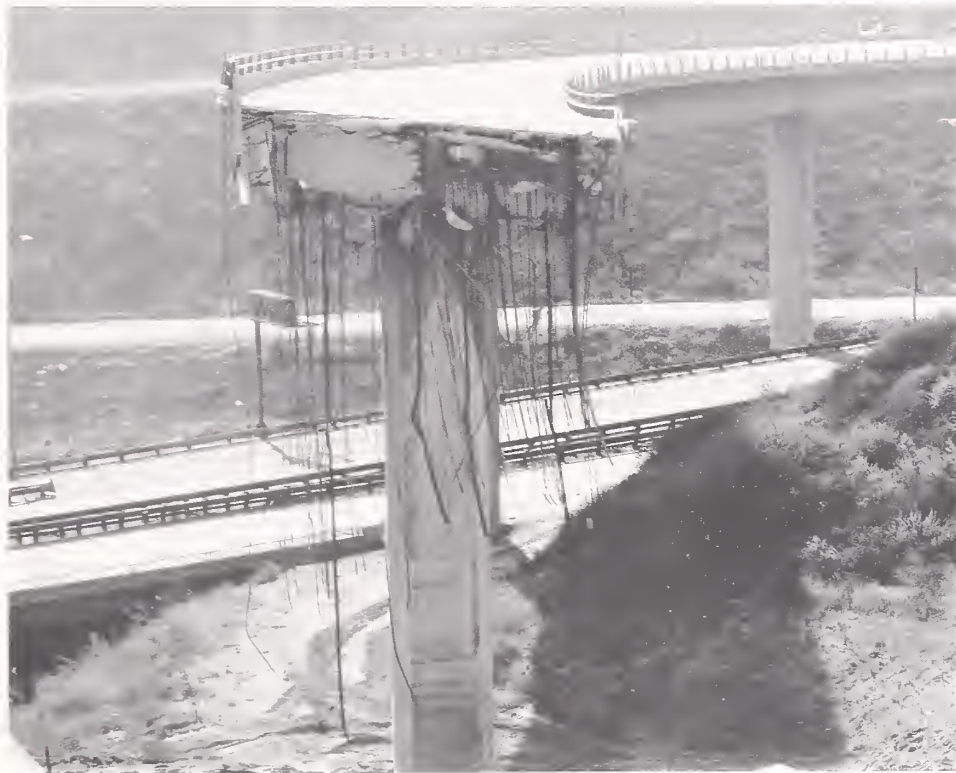
Figure 4.15. View of the flexural failure at Pier 3 of the SR14/I5 North Connector Overcrossing, looking to the south.

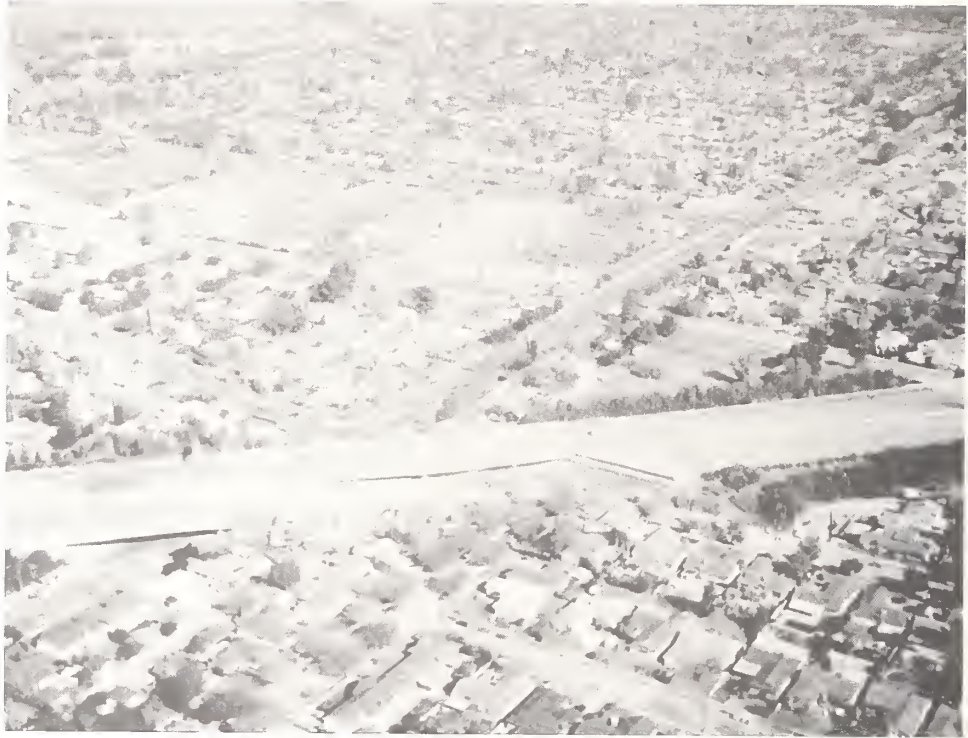
Figure 4.19. Aerial view of the SR118 Mission-Gothic Undercrossing, looking to the north showing collapsed eastbound bridge (Photo courtesy of FHWA).

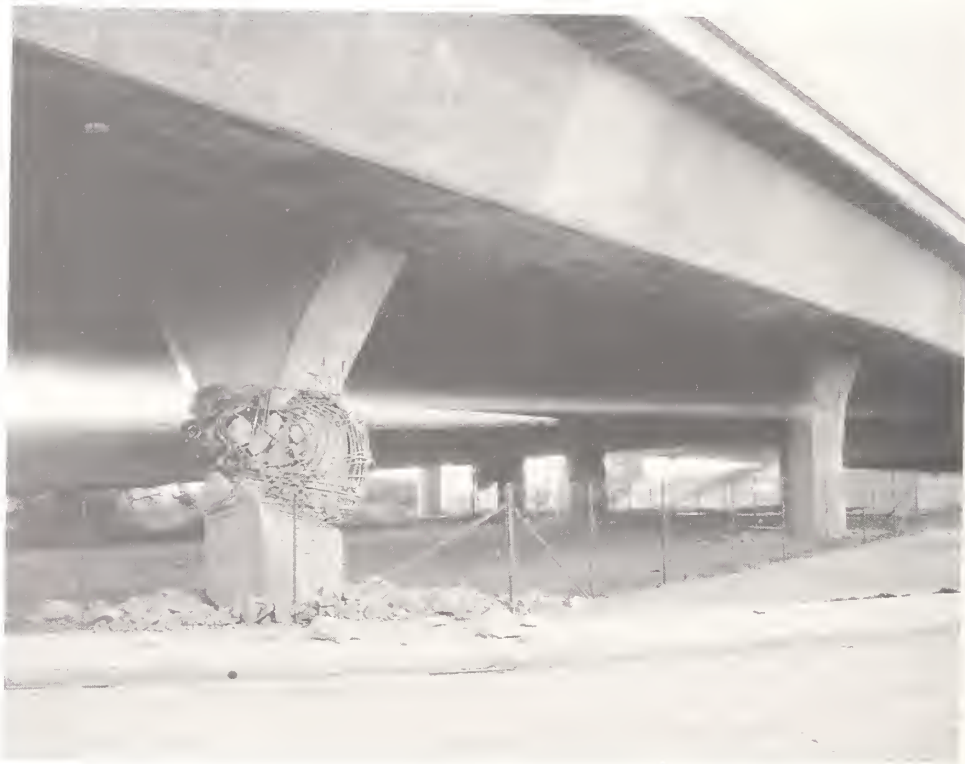
Figure 4.20. Damage to piers of the SR118 Mission-Gothic Undercrossing, looking to the northwest at the north face of the westbound bridge, Bents 3 (foreground) and 2.

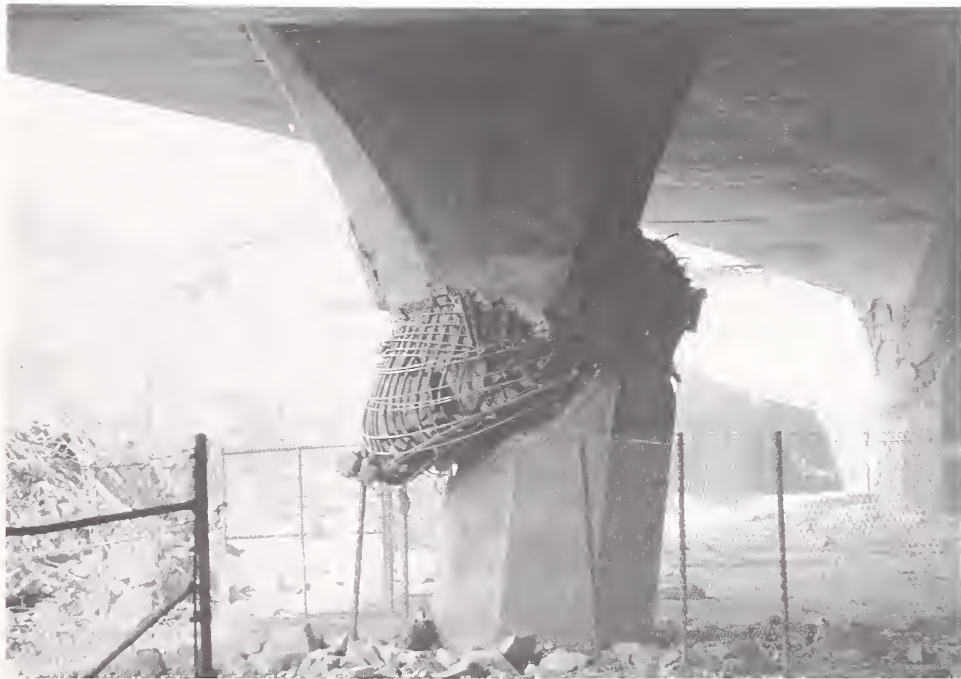
Figure 4.21. Damage to a pier of the SR118 Mission-Gothic Undercrossing, looking to the northwest at the southernmost pier of Bent 3 of the westbound bridge.

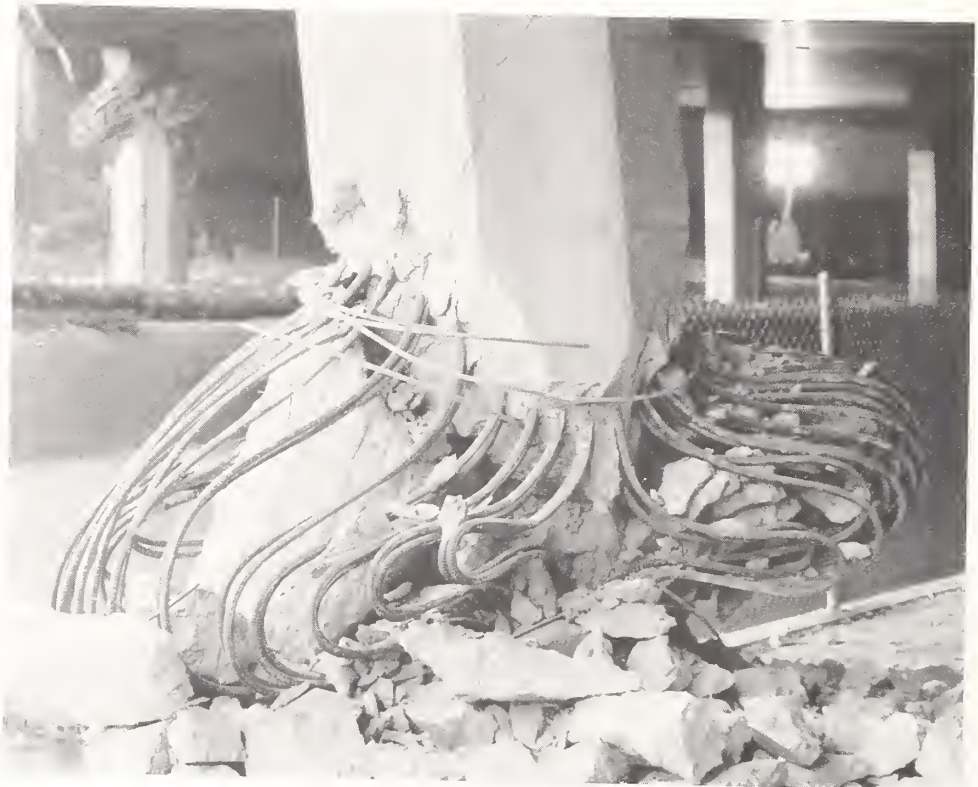
Figure 4.27. Damage to pier 3S-1 of State Route 118 at Bull Creek Canyon Channel, looking to the northwest.

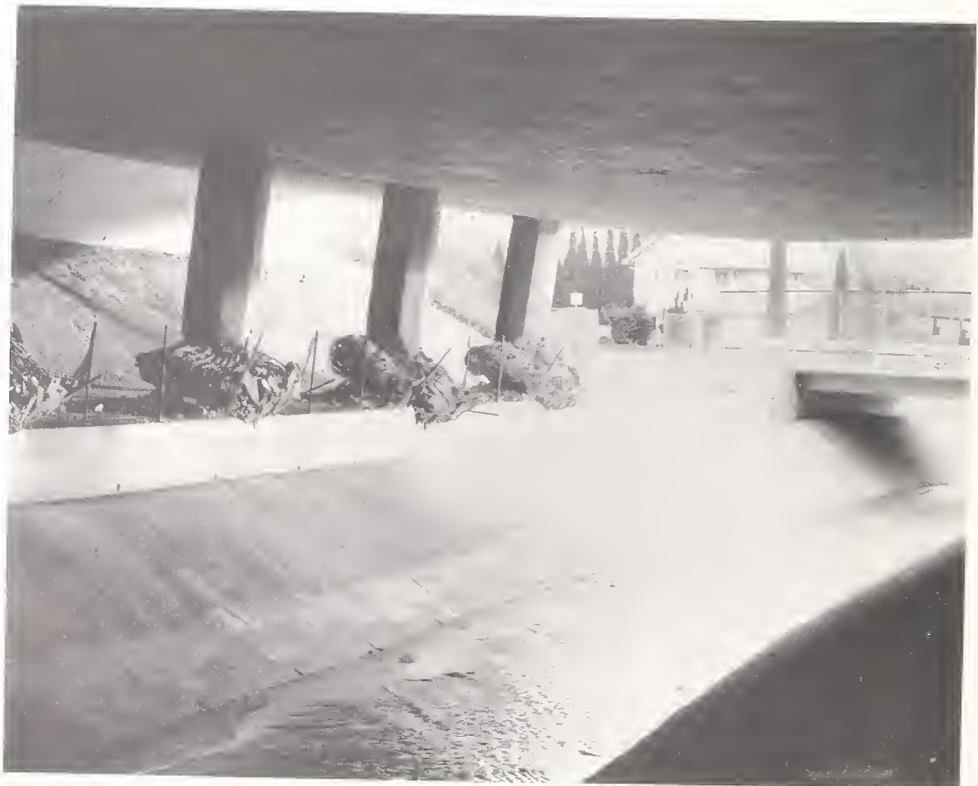
Figure 4.28. Damage to piers of Bent 3S of State Route 118 at Bull Creek Canyon Channel, looking to the southeast.

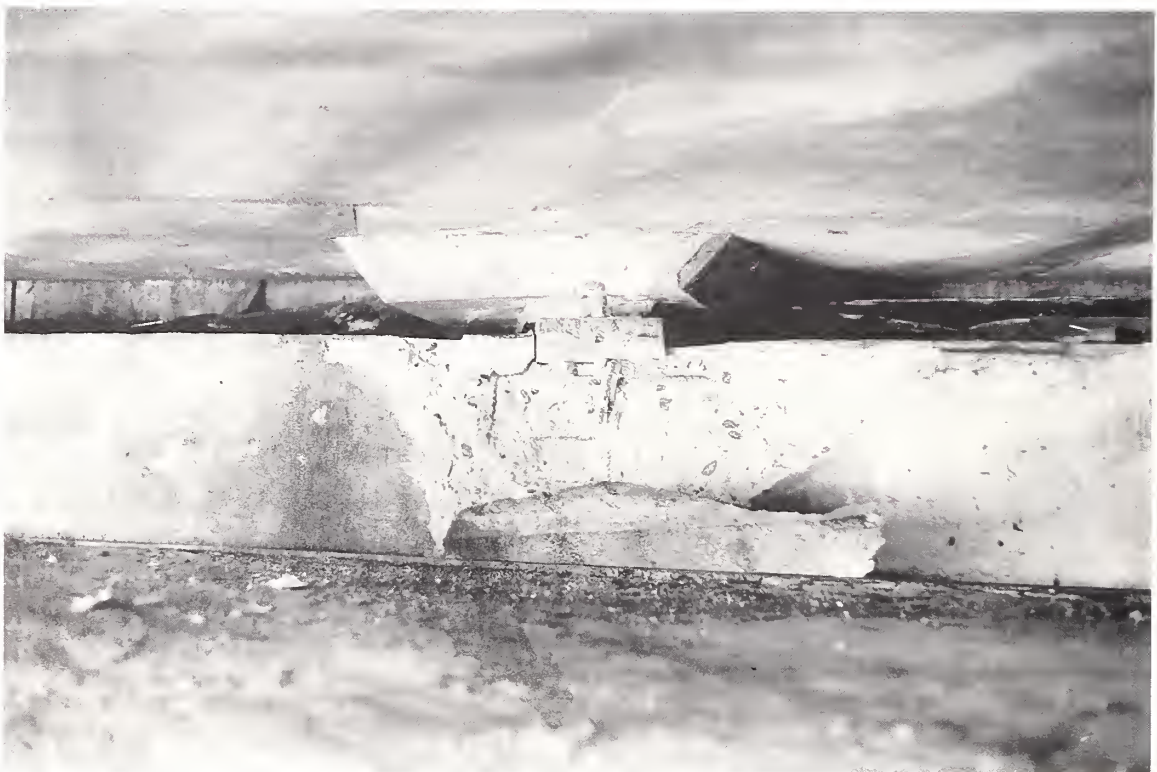
Figure 4.48. Abutment damage at sliding-type bearing.

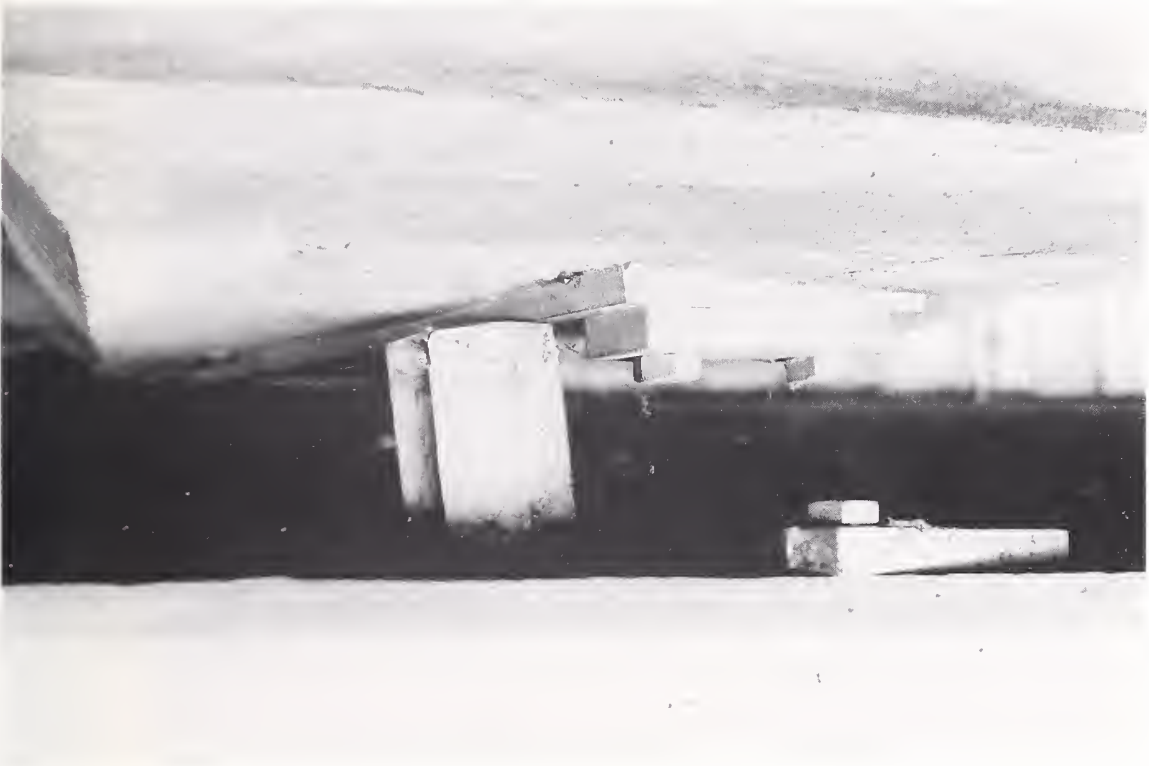
Figure 4.49. Displaced bearing block in rocker-type bearing.

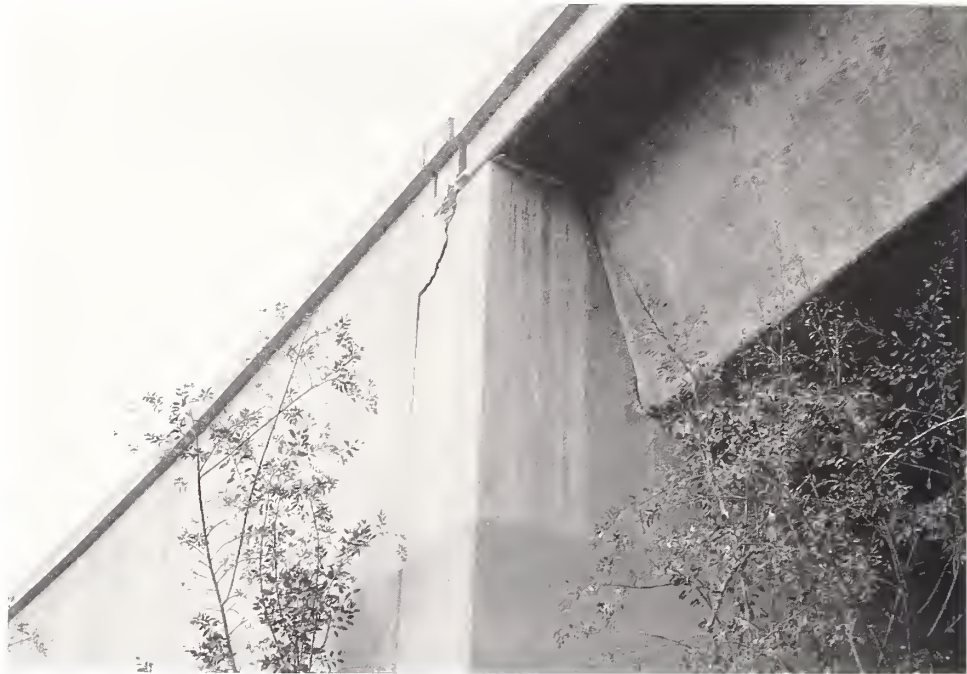
Figure 4.57. Close-up of abutment wall cracking at the east end of the ramp connecting eastbound SR118 with northbound I210.
